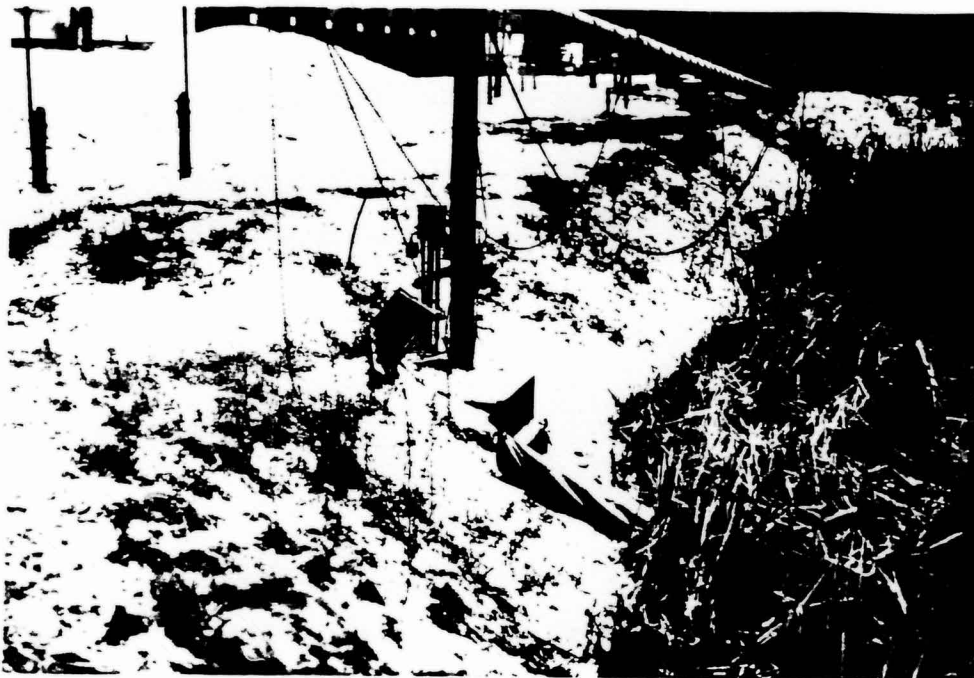
1.4 View of western edge of Lagoon (3/89).

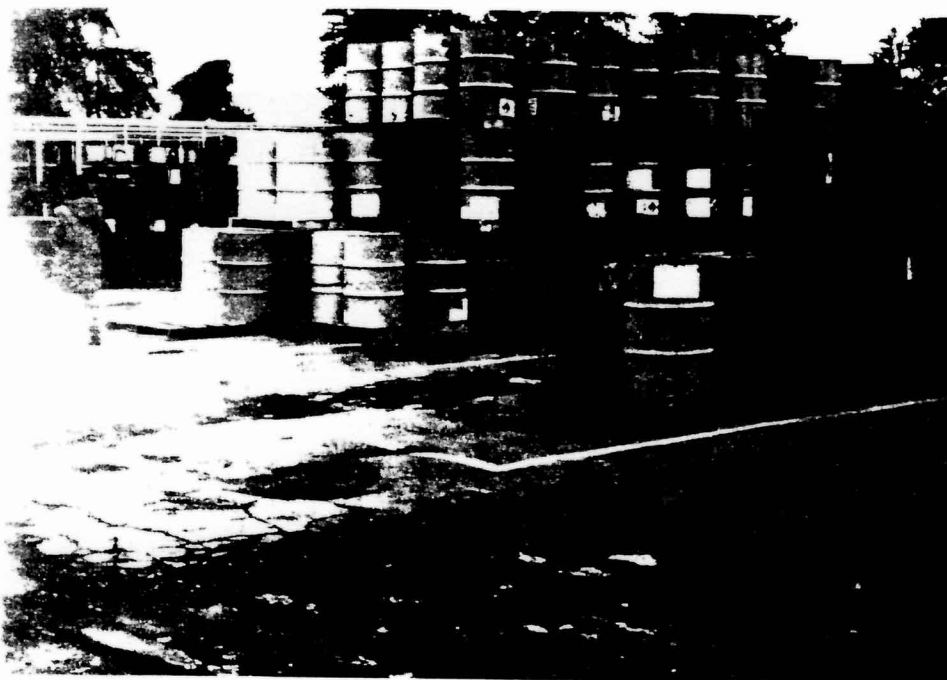
3.1 Overview of Drum Storage Area No. 1 looking west. Note that the cracks in the pad and that the unit is not diked (1/89).

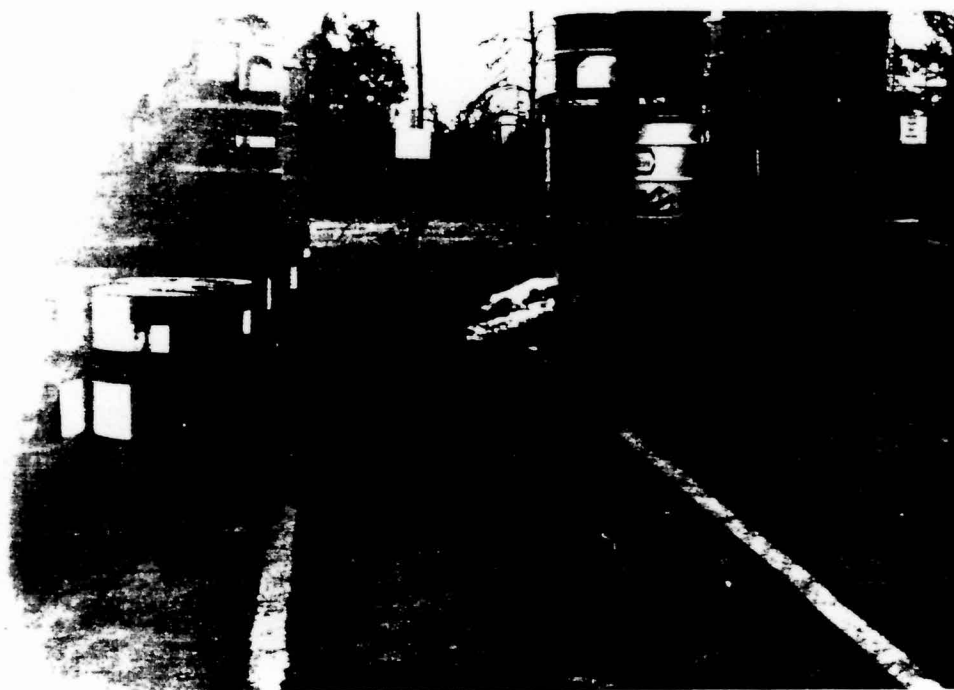
3.4 Drums stored within the Drum Storage Area No. 1. Note the condition of the asphalt pad and the concrete patches (1/89).

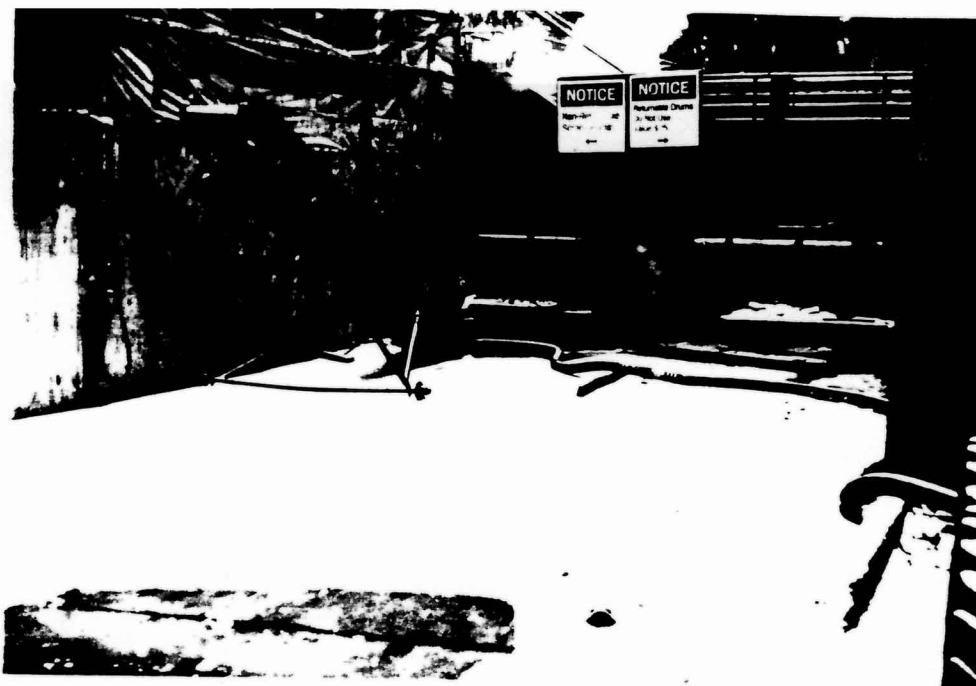
4.1 Drum Storage Area No. 2 looking southwest. The Filter Press shed is located on the southeastern side of this inactive storage area (3/89).

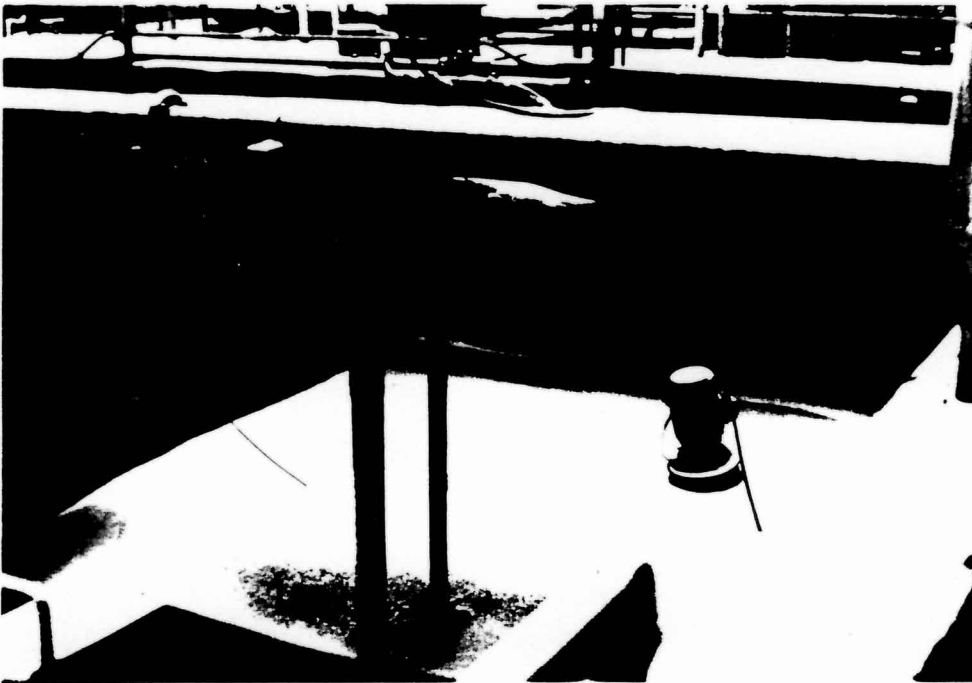
29.1 Contaminated Groundwater Tank. View is to the west. Note the aerator frozen in the ice (3/89).

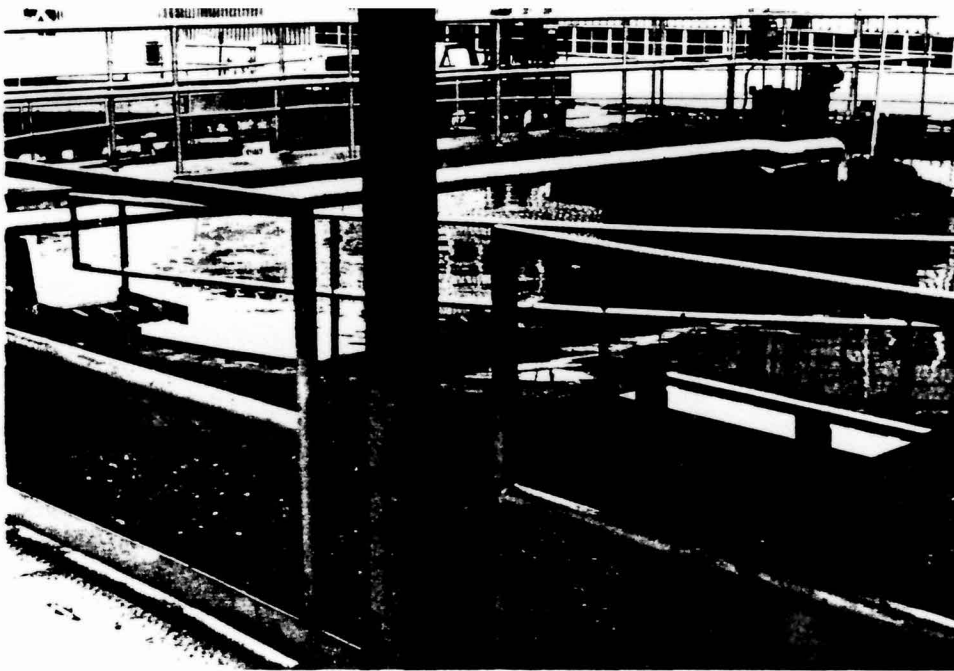
32.1 View of the Clarifier to the north. Note the stained concrete and Inactive Clarifier (SWMU 33) in the foreground (1/89).

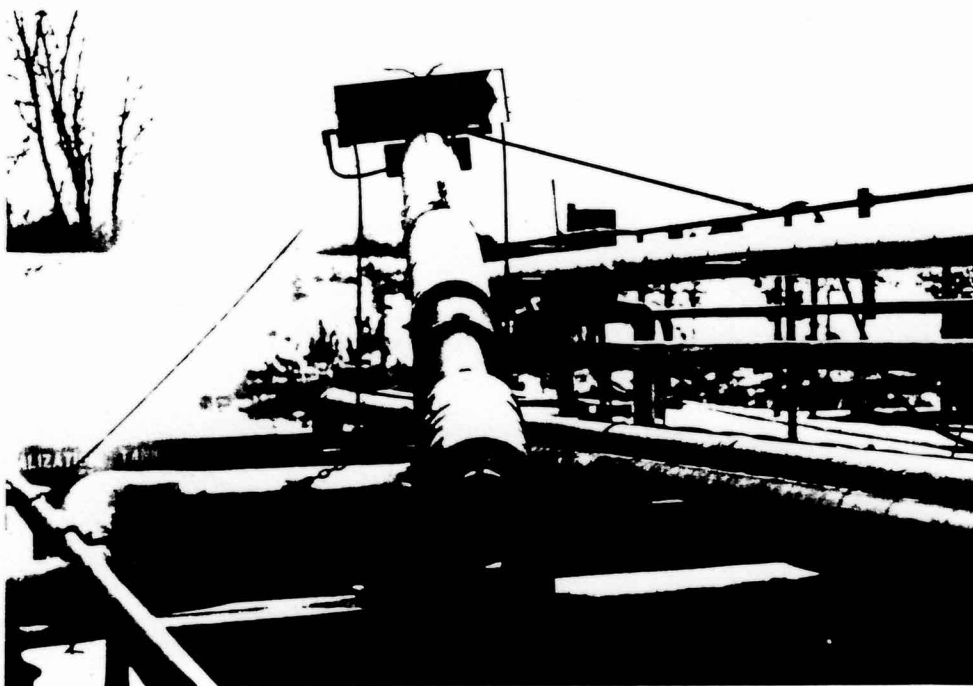
44.2 The Brill rope skimmer is used to remove floating oil from the surface of the wastewater in the Equalization Tank No.1 (3/89).

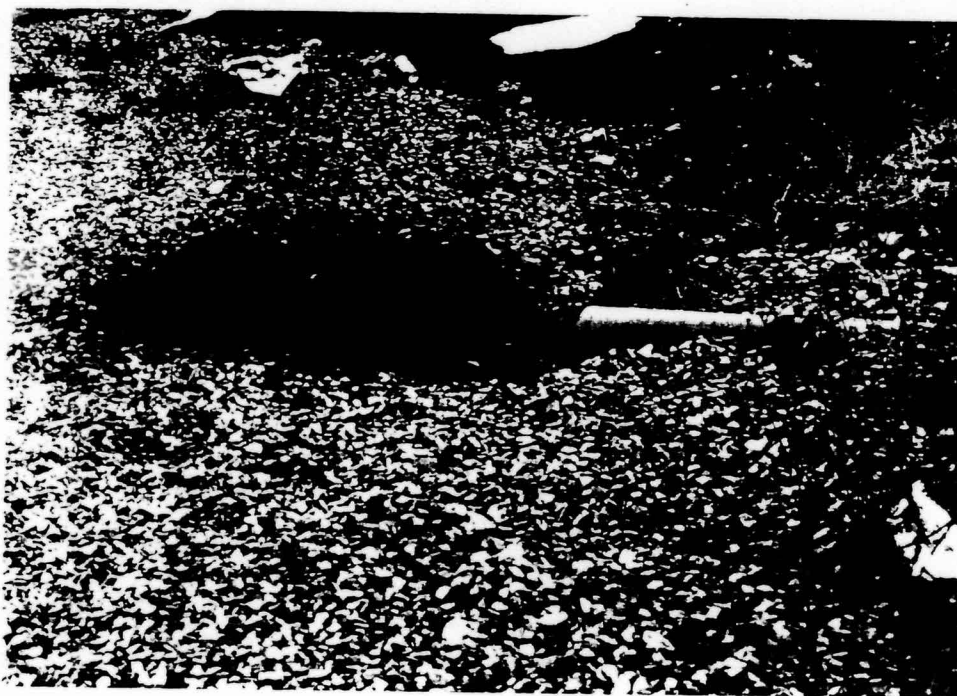
B.1 Oil staining at clay discharge point located just north of the Industrial Waste Sump (SWMU 41). View is to the east (1/89).
